TEST REPORT

Project No.: H13-30001

Test Report For: Composite shelter

Manufacturer : ARVIN SANAT BASPAR
Model : SLT 8040
Serial number : SMC1100

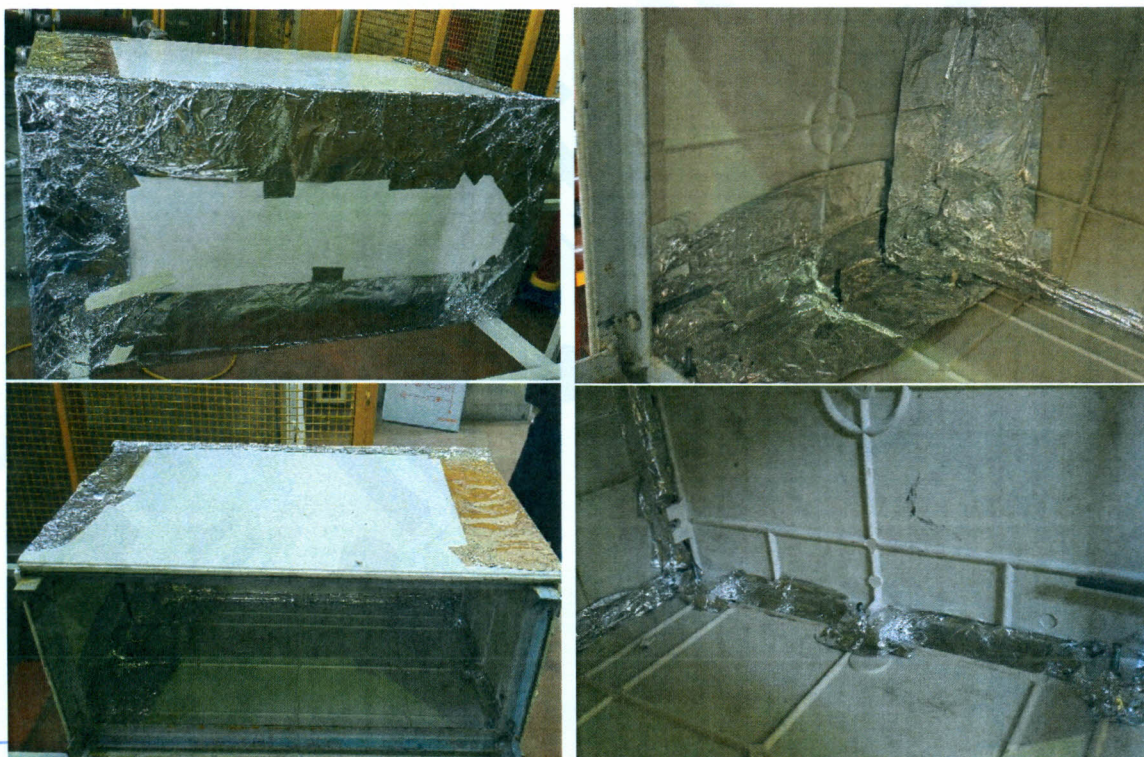
Figure 2: Metal foil that used for dielectric test

In case of the equipment under test, the enclosure is empty without any assembled devices. Thus, according to client request, the minimum possible distance between metal foil laid on the outside of enclosure over openings and prospective joints and live and exposed conductive parts is considered in the test using metal foil sheets on openings and joints inside of the enclosure. The inside foil acts as prospective conductive parts in the most unfavorable condition i.e. closest position to the enclosure walls. In normal condition, the assemblies are always placed in farther distance from enclosure walls, which leads to higher values of breakdown and withstand voltage values.

The test was carried out by applying an alternating voltage at power frequency (50 Hz) between outside and inside metal foils (see figure 2).

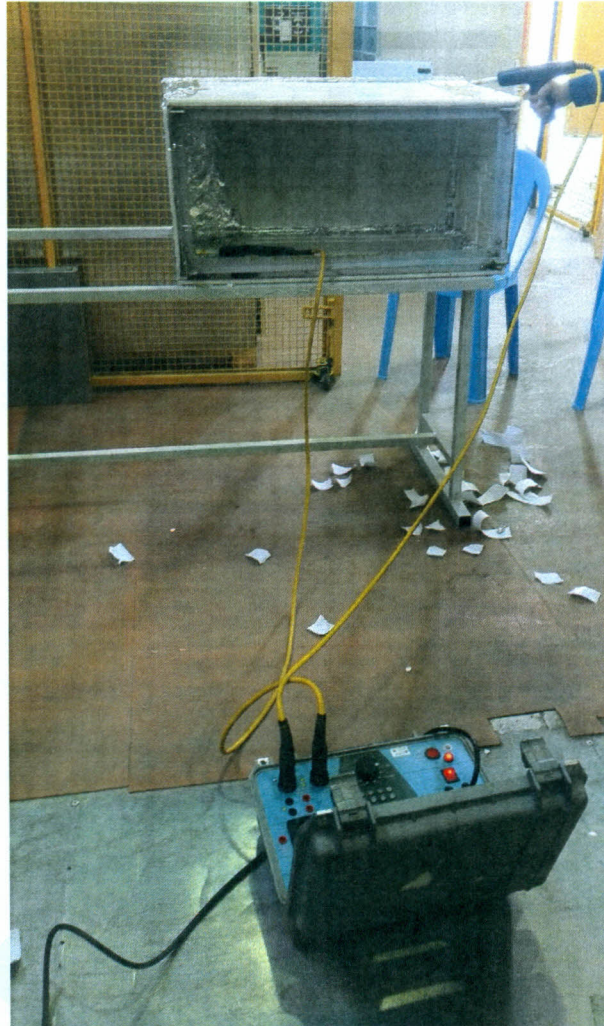
Figure 3: EUT under dielectric test

For breakdown voltage test, the applied voltage is gradually increased from zero until breakdown is occurred. Power frequency withstand voltage test is carried out by applying 4 kV between metal foils at inside and outside of the enclosure and maintained for 60 second. Table 1 shows the results of the test.
