IP TEST REPORT

Equipment Under Test: CRP BOX 30*40

Model/Type : CB 304013
S/N : 96072501
IP : 54
Dimension : SEE ANNEX

Tested According to: IEC 60529 2013 AND IEC 62208 2011

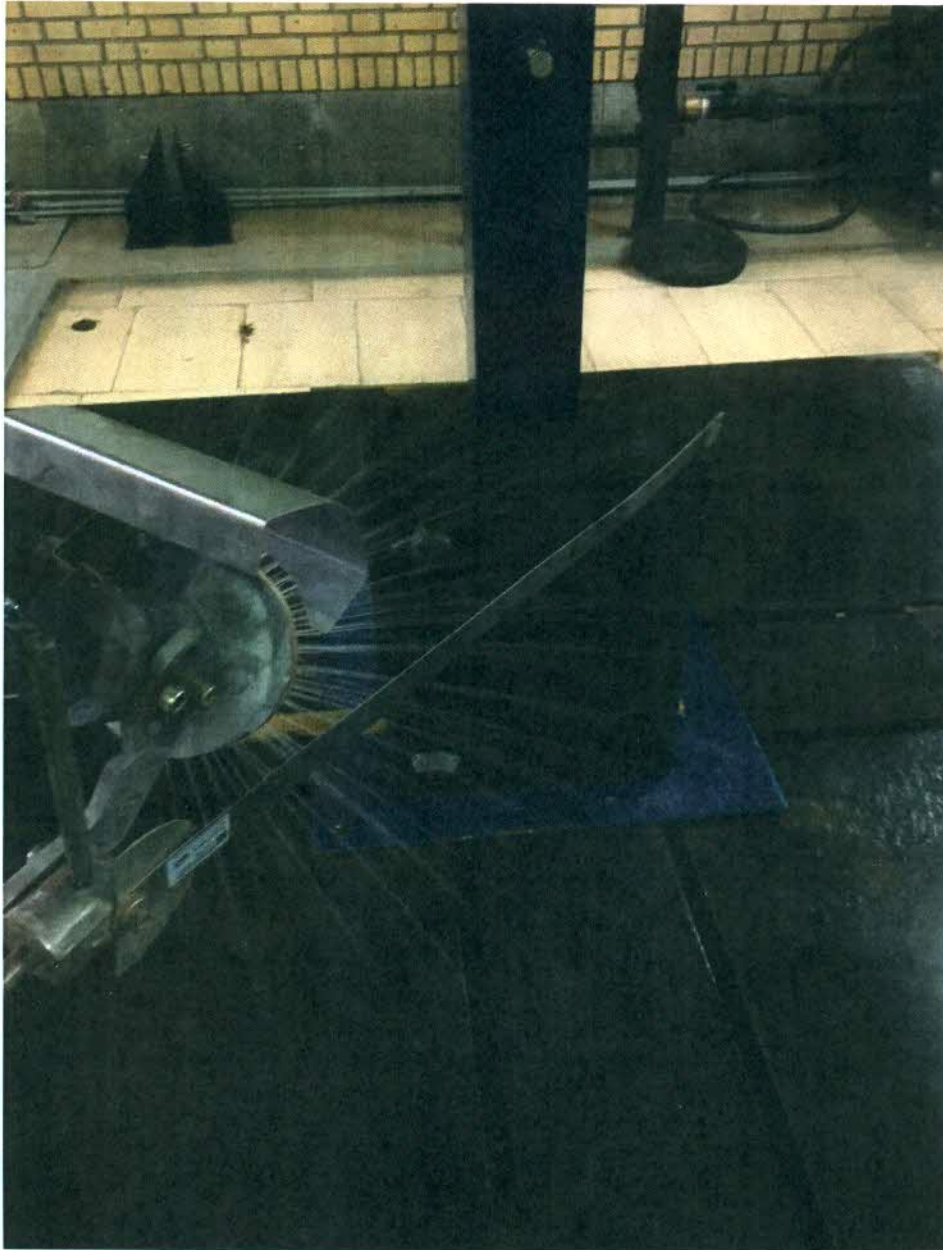
Figure 2: EUT under IPX4

The enclosure under test is placed in its normal operating position under the spraying with spray nozzle (According to IEC 60529).

The duration of the test was 1 min/m² at least 5 min (water flow rate: 10 L/min ±5%, according to IEC 60529).

After testing the EUT shall be inspected for ingress of water according to conditions that are specified in IEC 60529.

Test was done according to IEC 60529 and it passed the test.

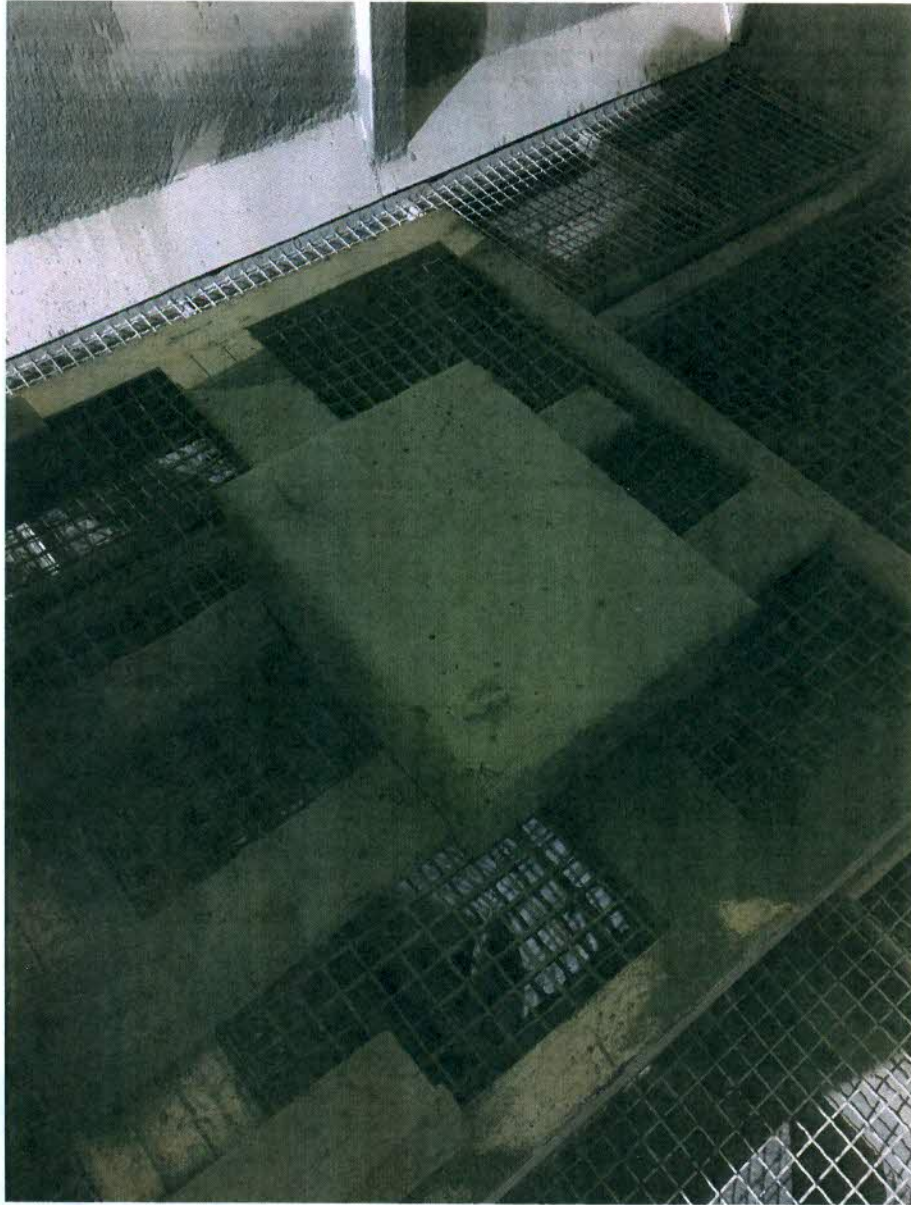
Figure 3: EUT after IP5X

The enclosure under test is placed in its normal operating position in dust chamber and the powder circulation pump worked. Talcum powder shall be used. The talcum powder used shall be able to pass through a square-meshed sieve the nominal wire diameter of which is 50 μm and the nominal width of a gap between wires 75 μm . The amount of talcum powder to be used is 2 kg per cubic meter of the test chamber volume. It shall not have been used for more than 20 tests (according to IEC 60529). The duration of the test was 8 h (according to IEC 60529).

Ingress of talcum powder is verified by using a watch glass installed at the center of the base of the protected space of the enclosure in order to pick up the talcum powder entering the protected space during the test. After the test, talcum powder shall not form deposits of more than 1 g/m^2 . In practice the weight of the watch glass is measured before and at the end of the test and the difference between both measures is representative of the amount of the talcum powder which has entered the protected space.

The test was done according to IEC 60529 and it passed the test.

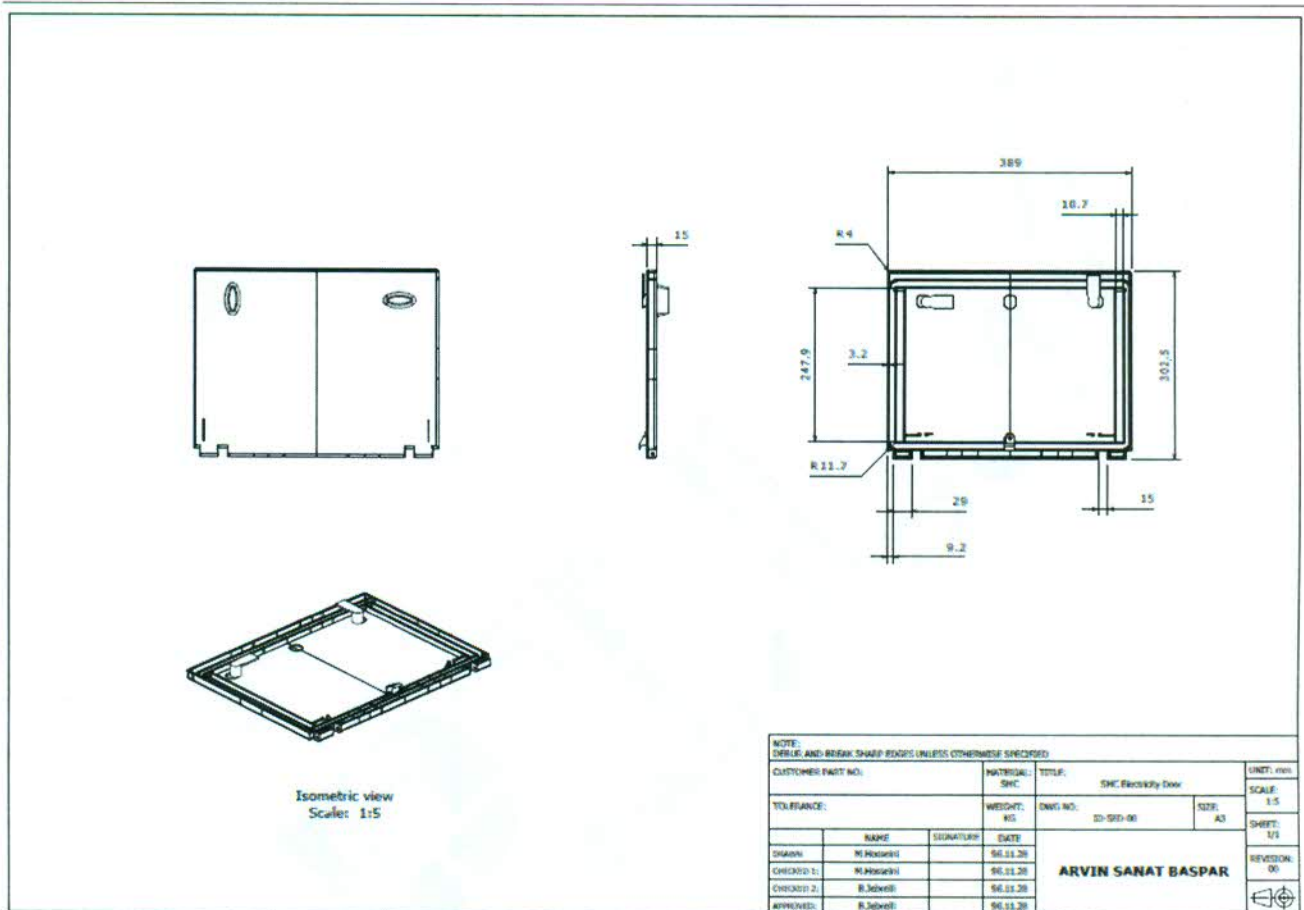
General view
